start Preliminary observations and conclusions regarding laser damage of tension plates and rotating torsion tubes of 7075-T6 aluminum alloy are presented. Good correlations between laser irradiance and physical damage measurements were observed. Load during laser damage has a beneficial effect on fracture strength of tension plates. Torsion tubes are highly susceptible to yielding crippling failure under combined load and narrow laser beam irradiation. Fracture mechanics procedures provide consistent results although scatter of damage and failure results indicate the advisability of using statistical rather than deterministic procedures. *END.*

This report presents data obtained from a series of laser damage and residual strength tests performed on tension plates and torsion tubes.

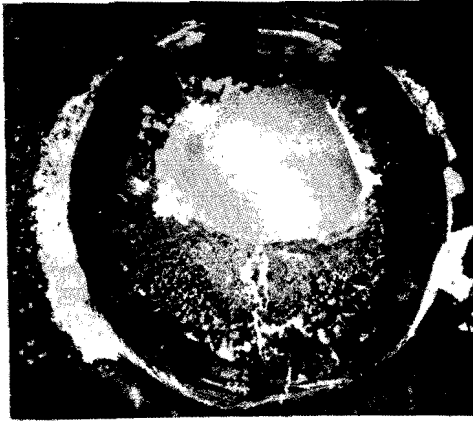
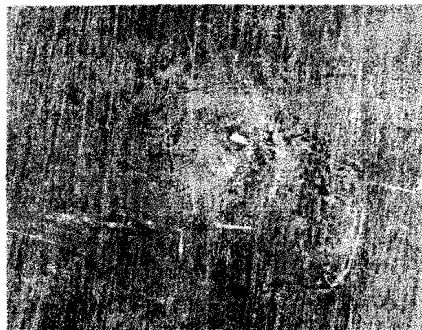
Figure 2. Typical laser damage to plates.

As a standard measure of damage the development of a zone of melted metal with pinpoint holes of incipient burnthrough was selected and designated "Condition 2." Partial control of the degree of damage could hopefully be maintained by establishing laser irradiance values for Condition 2 and reducing or increasing laser-on-time to control the damage. Figure 2 shows typical damage levels obtained.
